WHEN NATURAL AND TECHNOLOGICAL
HAZARDS COLLIDE

**OVERVIEW OF THE INDUSTRIAL ACCIDENTS
CAUSED BY THE GREAT TOHOKU
EARTHQUAKE AND TSUNAMI**

JAPAN, MARCH 11th, 2011

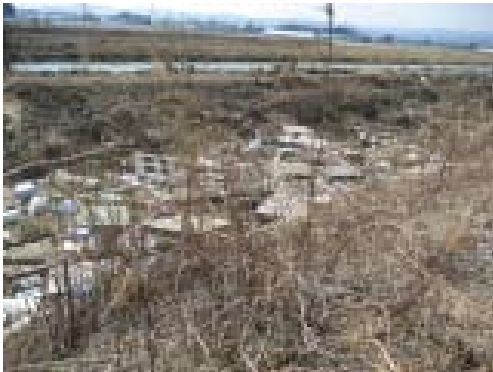
Interior of the warehouse
after the tsunami
(Source : JPR)

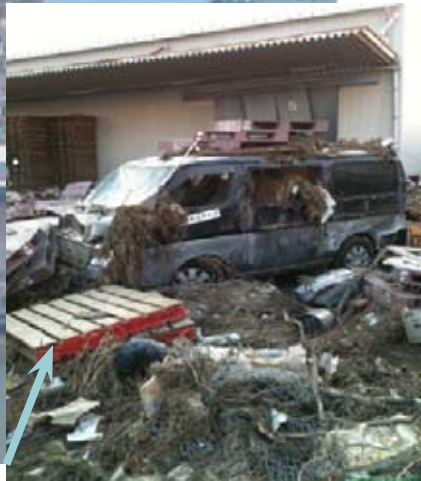
Debris and minivan deposited in front of
the warehouse by the tsunami
(Source : JPR)

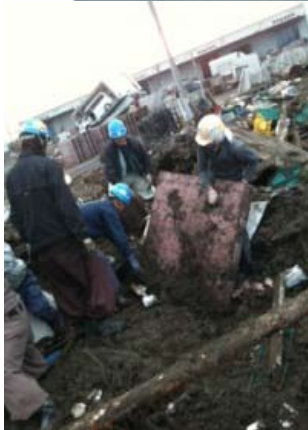
Collecting
pallets by hand
in front of the
warehouse
(Source : JPR)

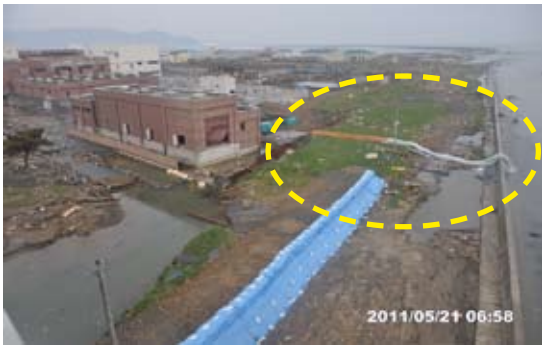
Emergency treatment at the Ishinomaki purification plant in May 2011 (amateur photo)

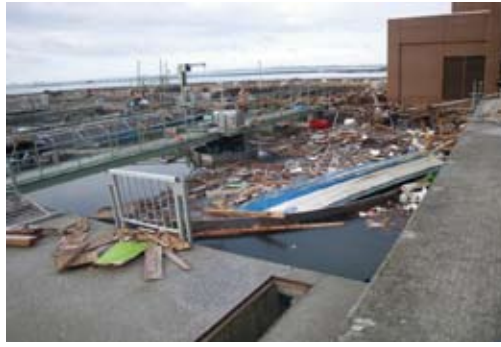
Debris in a settling basin at the treatment plant in the Port of Ishinomaki (Source : GWIA)

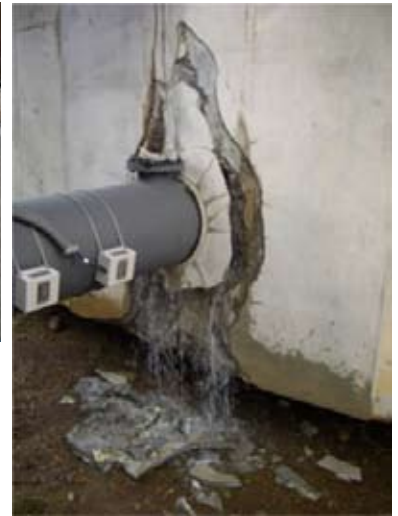
Damaged pipe of a settling basin (amateur photo)

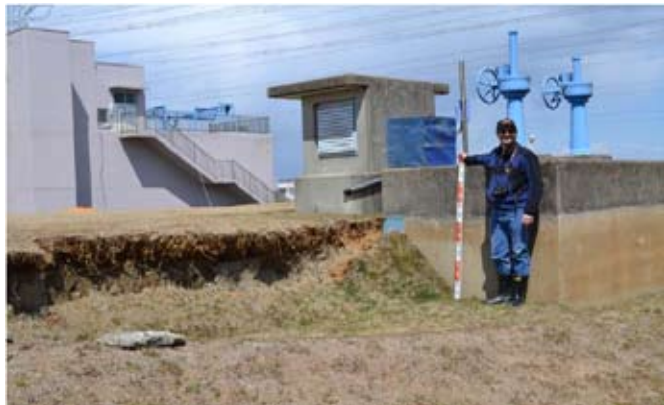
Liquefaction in the Waniigawa wastewater treatment plant in Kashima (amateur photo)

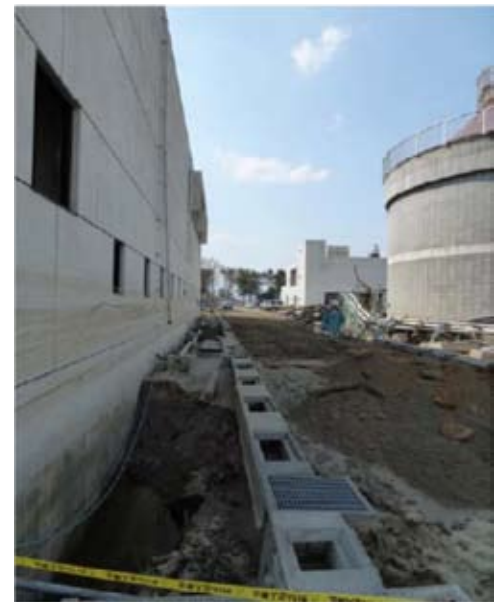
Soil erosion from the tsunami in a WWTP (Source : Miyagi Prefecture)

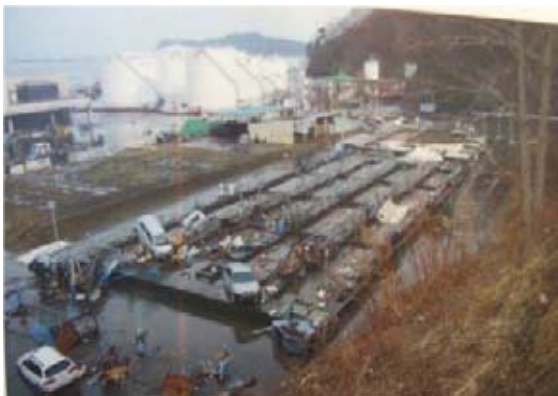
Settling basins in the Port of Kamaishi WWTP overrun with vehicles (Source : MLIT)

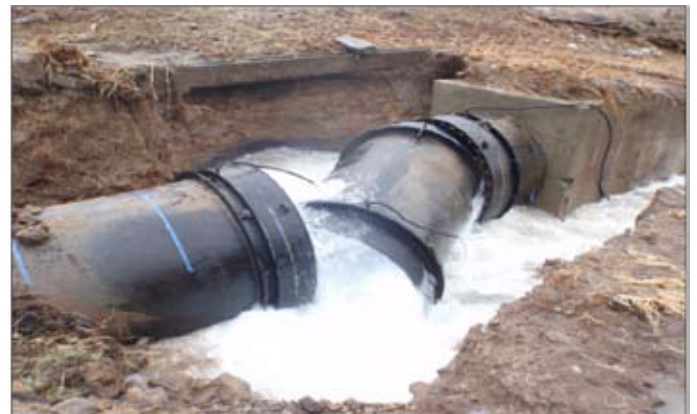
A 2400 mm (96") drinking water pipe that burst despite being fitted with a 500 mm deformable flange (Source : Miyagi Prefecture)

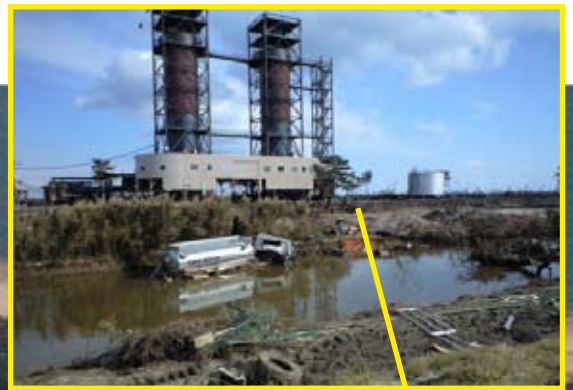
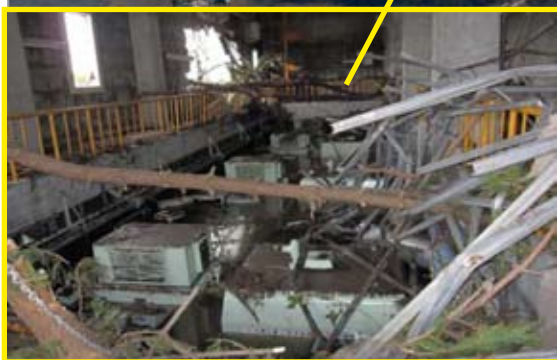
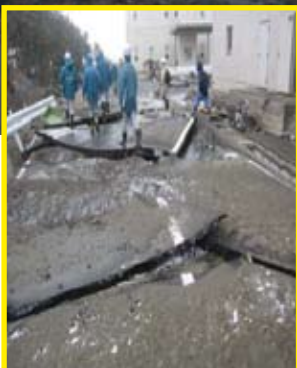
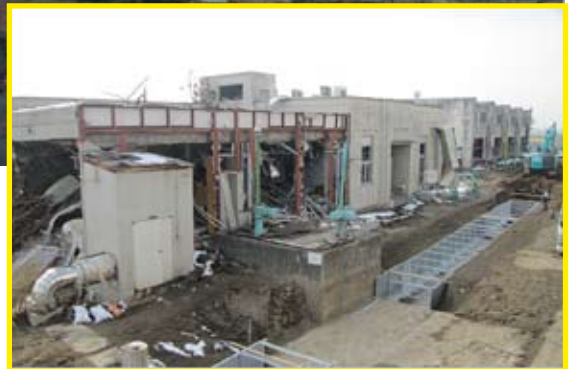
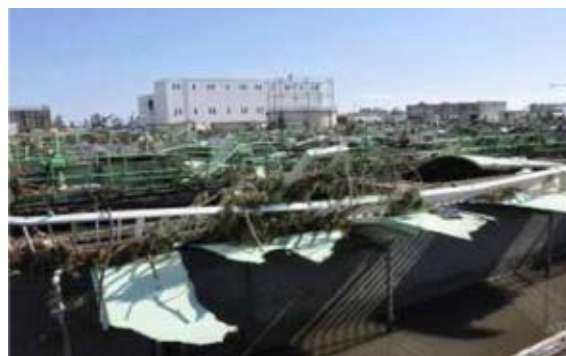
Casualties	None
Seismic damage	Soil liquefaction
Damage caused by the tsunami	<ul style="list-style-type: none"> Mechanical and electrical equipment destroyed (control room, electric transformers, pumps, aeration turbines). Protective seawall destroyed Treatment tanks clogged with debris and sediment. Erosion of soil around the bases of the structures. Leak on an expansion joint of a pond Roads and buildings parallel to the sea damaged Pipes displaced or damaged. Air leaks
Damage in €	€800 million (operator's estimate)
Chronology of resumption of operations	<p>14 March 2011: Emergency operations: primary settling, gravity flow (no electricity) used to drain out to sea (discharge pumps down)</p> <p>18 March 2011: Minimum treatment (post-chlorination by means of tablets only).</p> <p>Mid-April 2011: In-line chlorination system back in operation</p> <p>18 April 2011: Mobile system used to dry sludge from primary settling tanks</p> <p>First half of 2015: Scheduled completion of rehabilitation.</p>

Damaged roads and buildings
(Source : JWSA)

Technical lessons	<ul style="list-style-type: none"> Place the buildings' doors and windows parallel to the likely incoming direction of the tsunami so as to limit damage Place the maximum amount of electronic equipment on the first or second floors Improve the water resistance of ground-floor sensitive electrical equipment. Line the treatment tanks and channels with concrete
Link	ARIA 42431 online summary

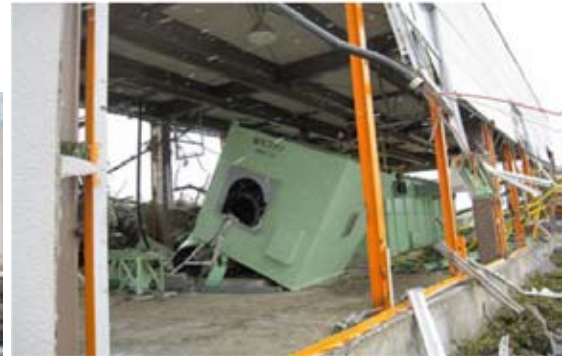
External damage: aeration tanks, pipes, treatment equipment (Source : Miyagi Prefecture - JWSA)

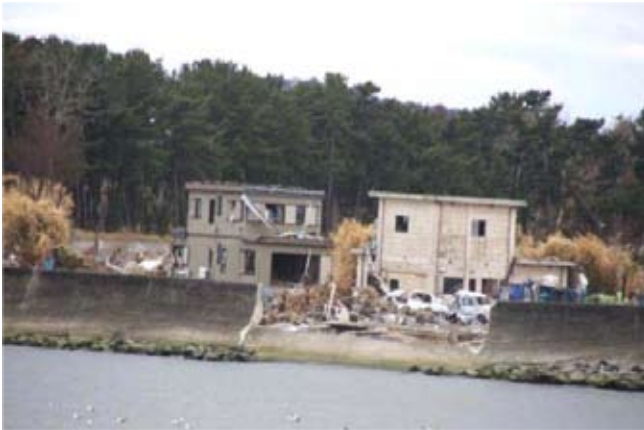
A dike section breached by the tsunami near the mouth of the Naruse river (Source : GEER)

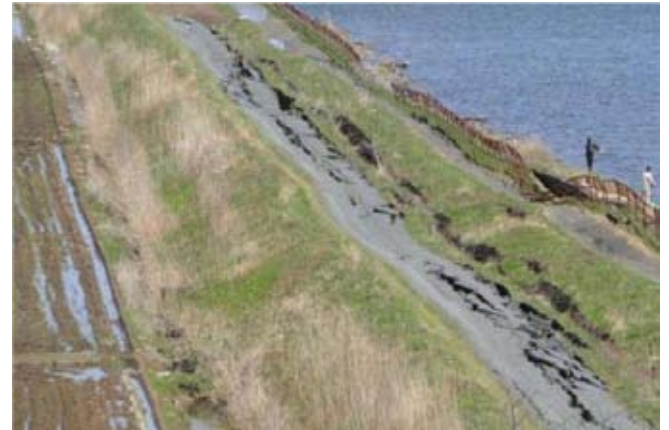
Liquefaction along the right bank of the Hinuma river
(Source : GEER)

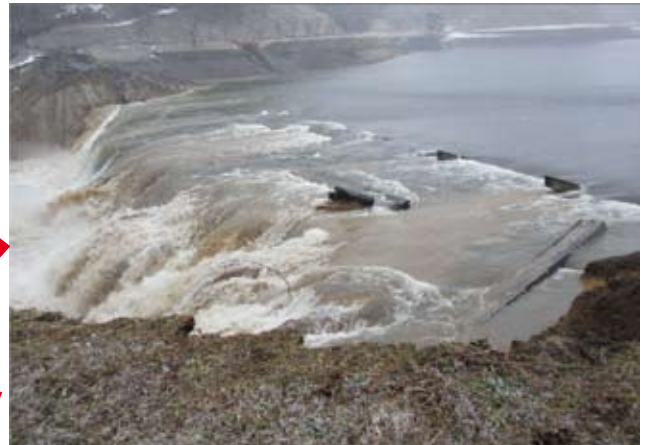
Seismic damage	<ul style="list-style-type: none"> Structure levelled. Downstream road bridges and river dikes damaged Nine homes in the town below the dam were washed away
Causes of the failure according to Fukushima Prefecture's experts	<ul style="list-style-type: none"> The fill materials at the middle and top of the embankment were not strong enough. The means and techniques available after WWII did not achieve the degree of compaction needed to withstand cyclic loading (such as during an earthquake) Different types of fill materials used. Because construction of the dam was halted by WWII, different materials were placed at different times. The different mechanical properties led to a seepage and flow regime that was poorly understood Improper foundation preparation: the presence of a layer of organic-rich soil (including tree stumps) seems to indicate that the land had not been sufficiently grubbed beforehand

Breach of the main dam on March 11th, 2011 at 15.11 (Source : M. YOSHIZAWA)

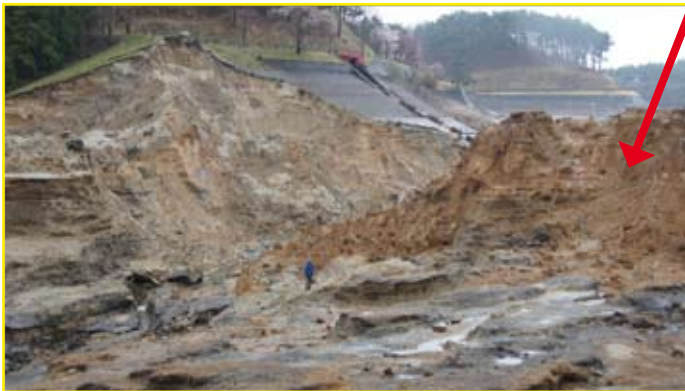
Likely mechanism	<ul style="list-style-type: none"> Main dam: upstream slide within the dam that led to its weakening and breach Auxiliary dam: upstream slide caused by a loss in strength or the rapid emptying of the reservoir
Recommended material changes	Due to the materials used to build them, some old dams have a much lower mechanical strength than modern dams. Despite being built without any difficulties and in accordance with the standards of the time, they may actually not be safe
Link	ARIA 40122 online summary

Breach in the main dam (Source : GEER / L.F HARDER)

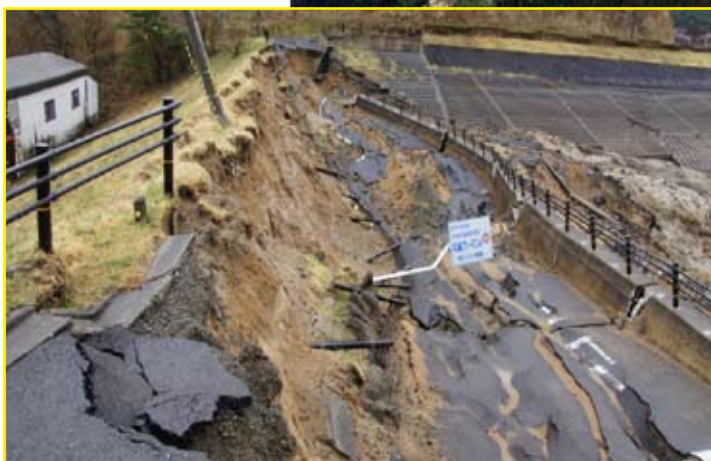
View of the slide in the auxiliary saddle dam, probably triggered the rapid emptying of the reservoir (Source : GEER / L.F HARDER)

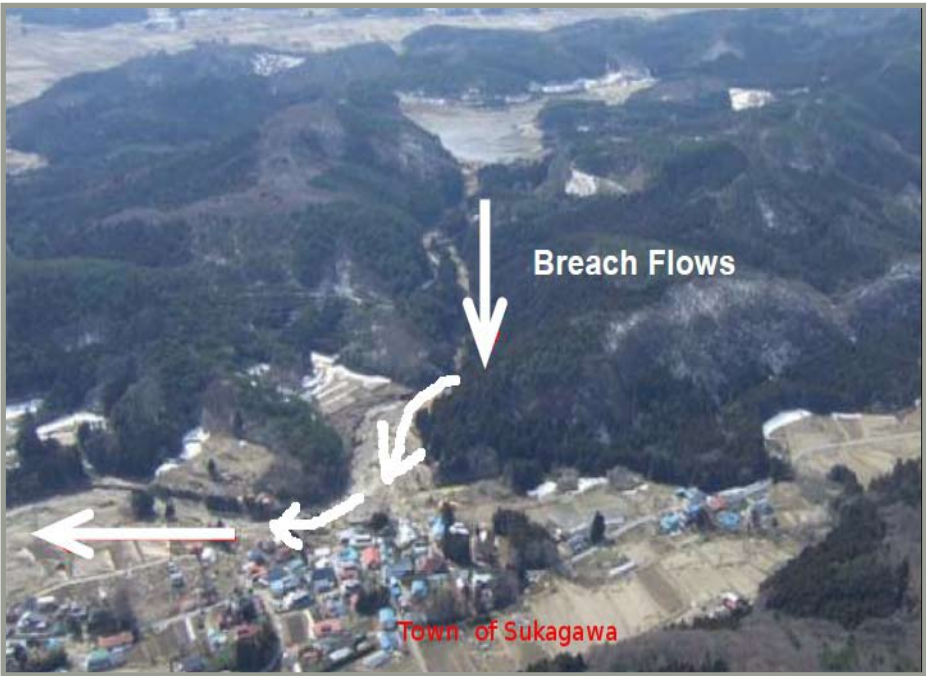
Aerial view of the path of the dam-break flood wave
(Source : MLIT / GEER)

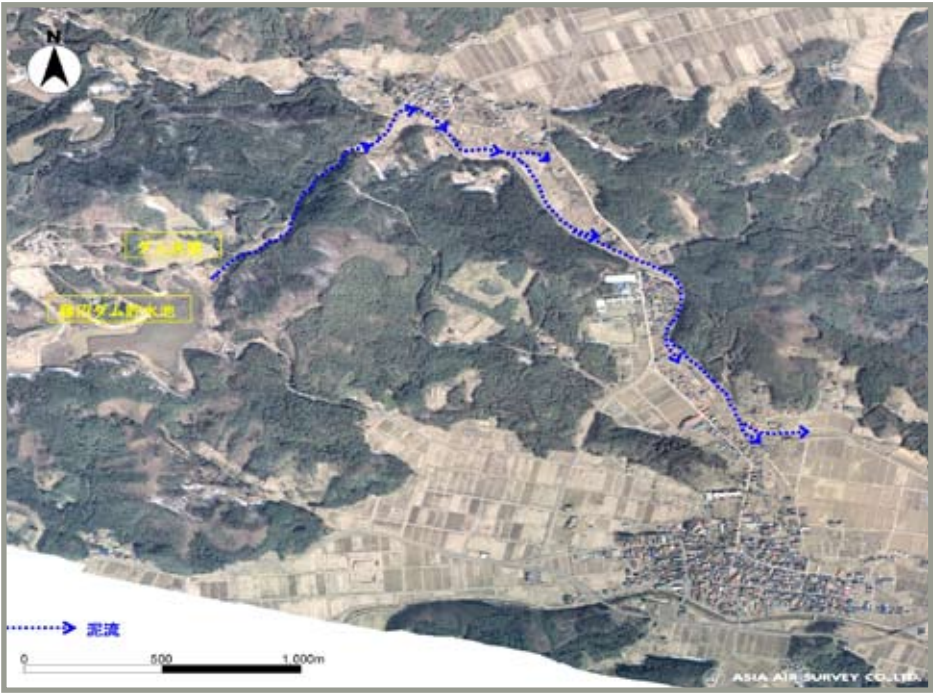
Satellite view of the path of the dam-break flood wave
(Source : Asian Air Survey)

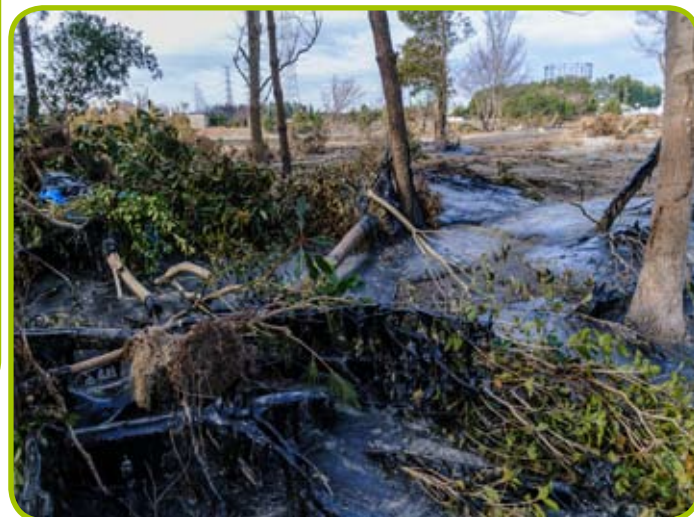
The area near the JX refinery in Sendai in April 2011 (amateur photo)

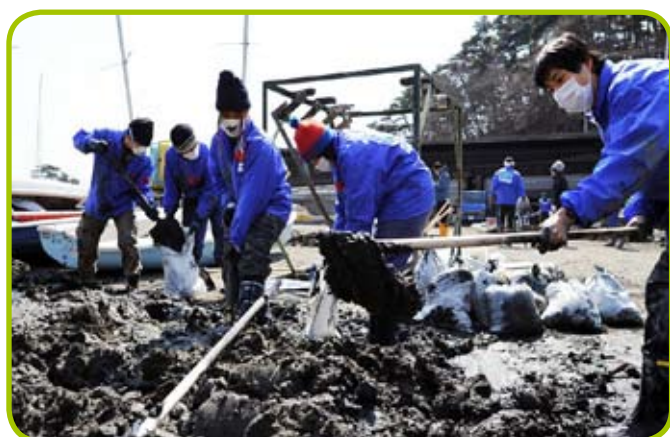
Environmental remediation behind the JX Nippon Oil refinery in Shiogama Bay above Sendai
(amateur photo)

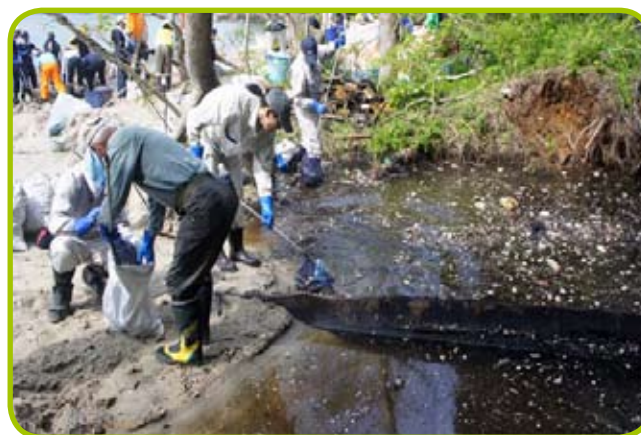
Volunteers cleaning up spilled hydrocarbons in Kesennuma Bay in June 2011
(amateur photo)

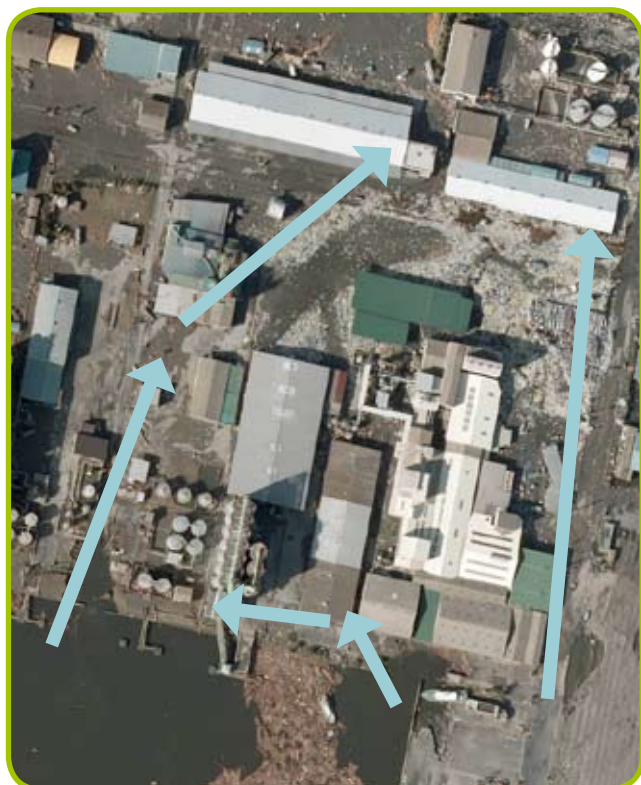
The blue arrows show the path of the tsunami in the plant
(Source : Fukuei fertilizer / Google maps)

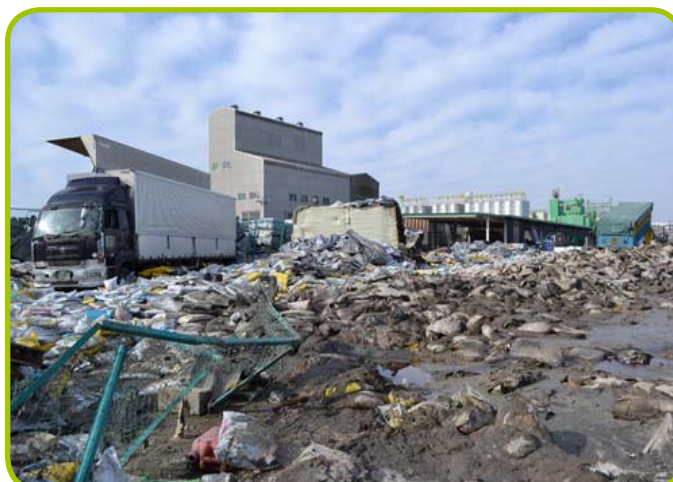
8,000 tonnes of bagged fertilizer were swept out of the Fukuei plant by the tsunami and scattered in the Port of Ishinomaki
(amateur photo)

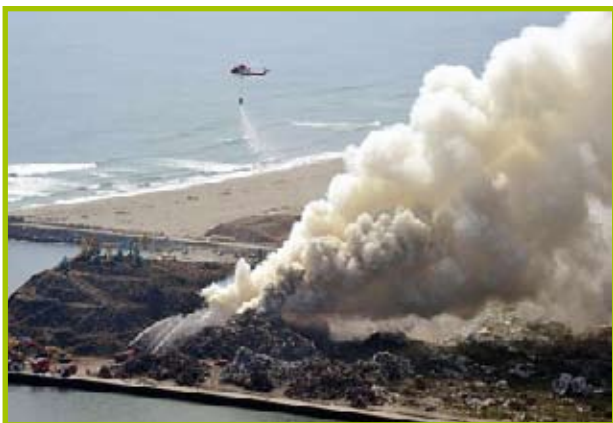
Fire at a temporary waste storage site in Natori on May 16th, 2011 (Source : Yomuri online/ Yusuhiro Takami)

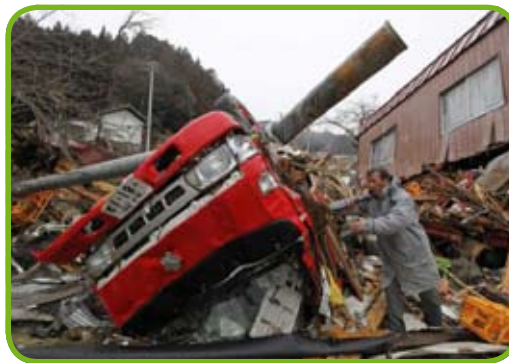
*A man searching for the body of his son, a volunteer firefighter, in the wreckage of a fire truck in the town of Rikuzentakata on March 16th, 2011
(Source : EPA/ Dai Kurokawa)*

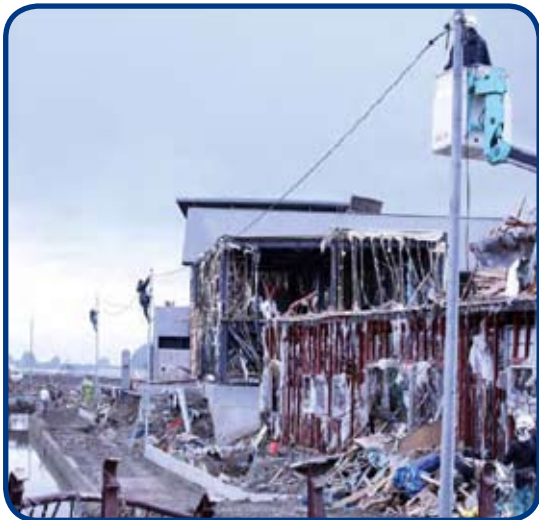
Telephone lines being repaired in Ishinomaki
(Source : NTT)

385 telephone exchanges, 4,900 GSM towers, 6,300 km of overhead lines and 65,000 telephone poles were damaged by the tsunami that struck the Tōhoku coast

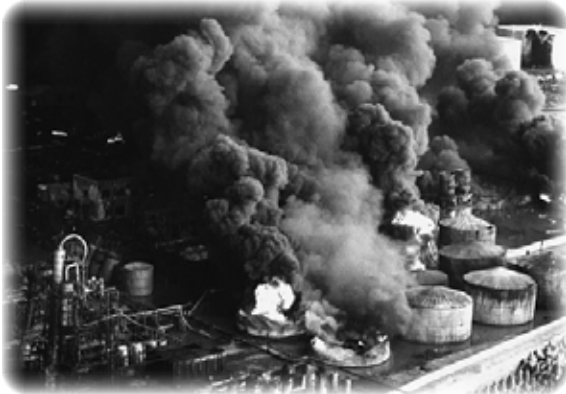
The 1964 Showa Oil Niigata refinery fire (144 storage tanks and 236 homes burnt) prompted the adoption of the first NaTech regulations specific to industrial sites. On 11 March 2011, the site sustained only limited damage to its oldest tanks, which were not up to standard. (Source : MLIT)

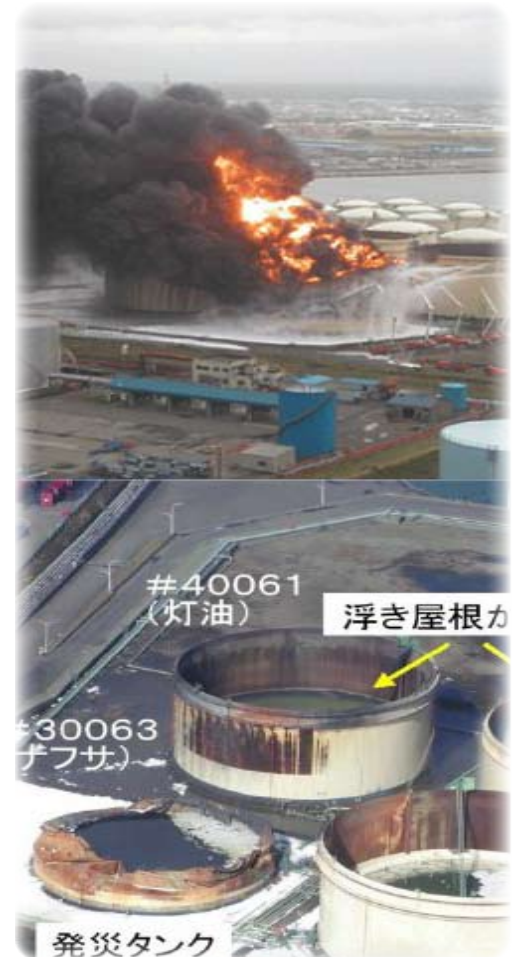
Fire on a light naphtha storage tank 48 hours after the 2003 Tokachi-Oki earthquake (Mw = 8) of May 2003. The quake sank the floating roof on this tank and a dozen others at the Tomakomai refinery on Hokkaido Island. Because there was not enough foam on the site, the fire lasted for 44 hours, during which additional supplies were imported from eight countries. Japanese regulations on petroleum complexes were subsequently tightened to allow operators of petroleum sites to share their firefighting response systems more efficiently (Source: NRFID)
